## **FACILITY ASSESSMENT REPORT**

**YOAKUM COUNTY HOSPITAL**

**Denver City, Texas**

Parkhill Project # 45841.25

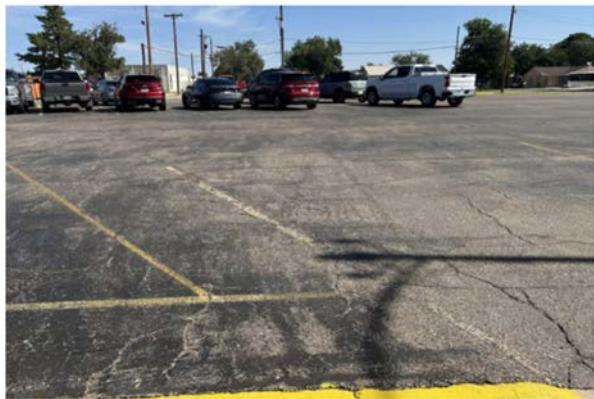
The pavements are in poor condition with cracks sprawling throughout a majority of the paved areas that are larger than 1-inch in width. However, since there is no vertical elevation difference, a remediation option might be to strip the surface pavement and rework the base, including proof rolling prior to overlaying the HMAC surface with a depth to match what was existing prior to removal. Additionally, several areas within the pavements exhibit poor drainage, which will require improvement.

Figure 1 – East Parking Lot

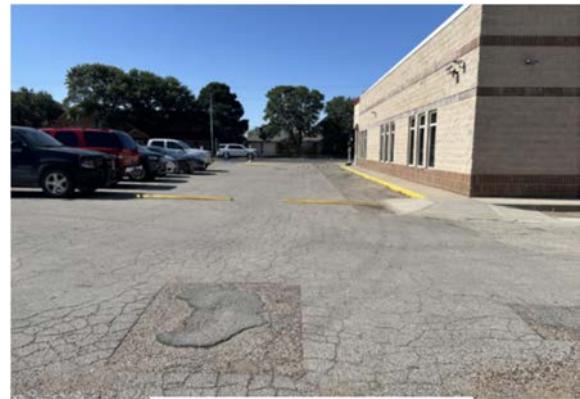
Figure 2 – East Drive of the Health Center

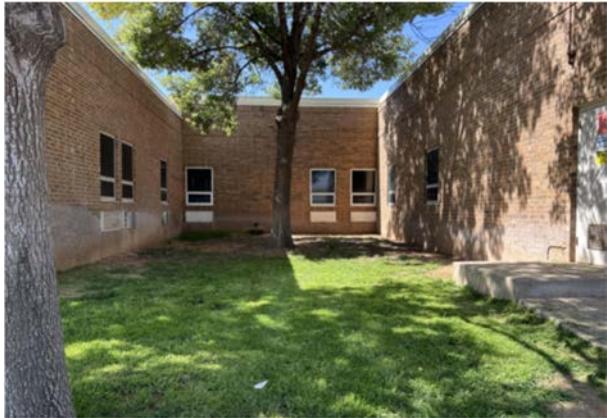
Observations indicate that surface drainage adjacent to the existing hospital building is functioning adequately, with no visible signs of moisture accumulation or water ponding along the building perimeter. However, beyond the immediate vicinity of the structure—particularly within the surrounding pavement areas and the service court—positive drainage appears to be insufficient. These areas exhibit poor surface runoff characteristics, which may lead to localized ponding or long-term pavement degradation if not addressed. Further evaluation and potential grade improvements are recommended to enhance overall site drainage performance.

Figure 4 – North Courtyard

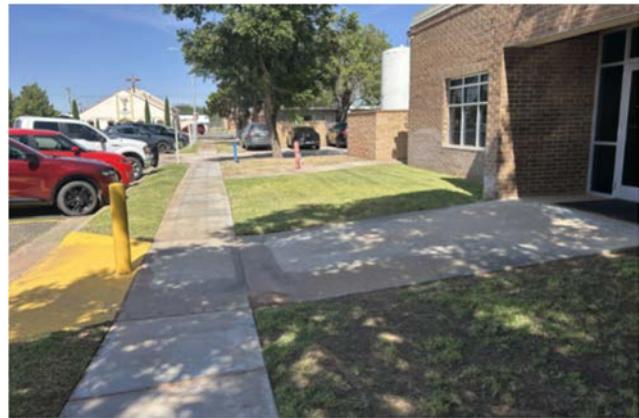
Figure 5 – South Entrance to Rehab Center

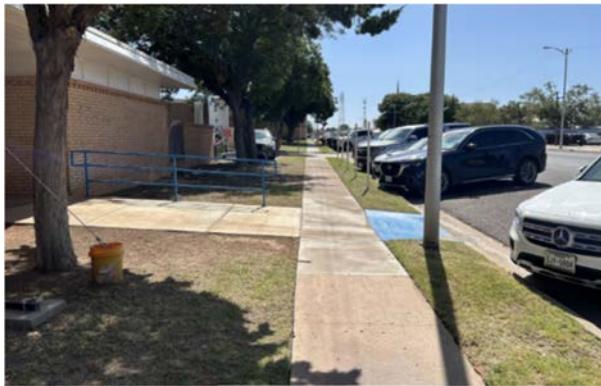
Figure 6 – Southwest Corner

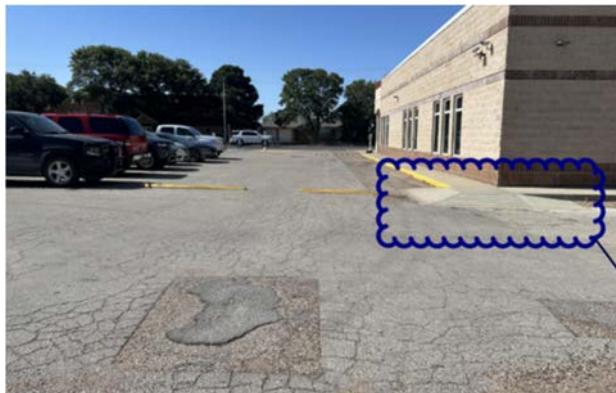
Multiple areas across the site appear to be non-compliant with current ADA standards. Several ramps were observed to have incorrect configurations, including slopes exceeding the maximum allowable 1:12 ratio and lacking proper landings or edge protection. Parking areas also exhibited slope conditions that are likely to exceed the 2% maximum in any direction, as clarified in the 2025 ADA updates. Additionally, handrails on existing ramps do not meet the latest ADA specifications, such as proper height (34–38 inches), continuous gripping surfaces, and required extensions beyond ramp segments. To ensure full compliance with today's ADA standards and avoid potential enforcement actions, all identified deficiencies will need to be addressed through corrective design and construction measures.

Figure 7 – Non-Conforming Ramp East Drive Health Center

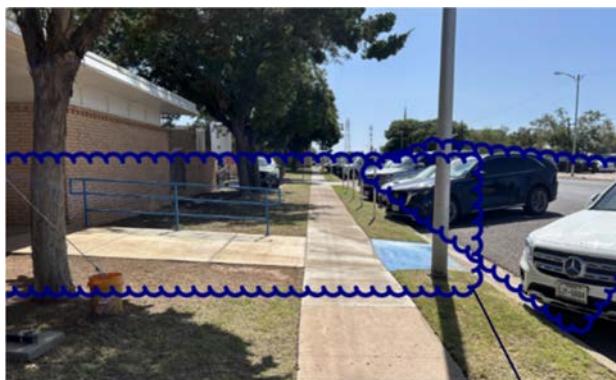
Figure 9 – Non-Conforming Ramp and Parking

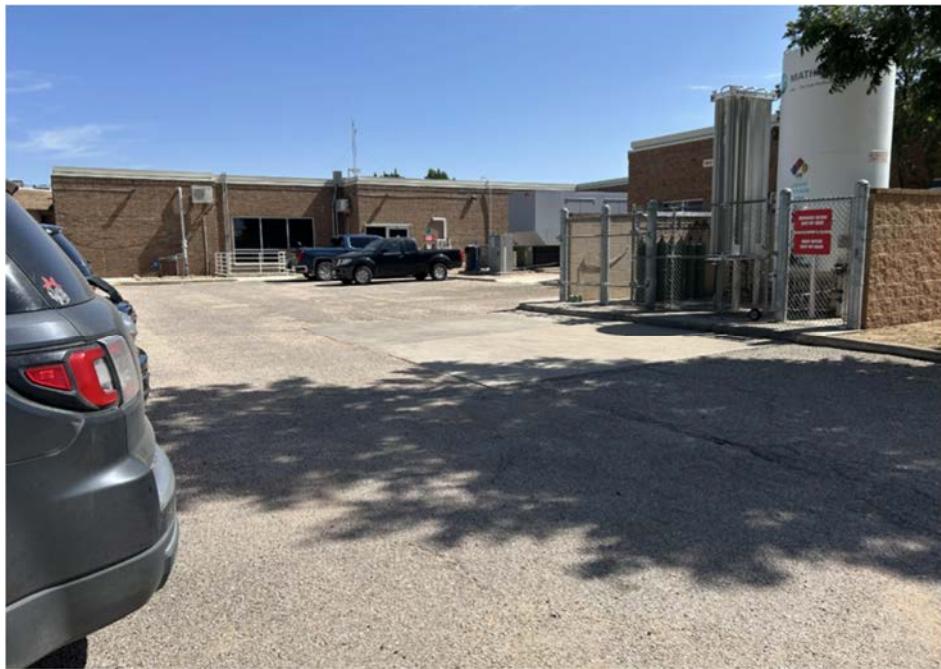
*Figure 10 –South Service Court*

The condition of site utilities was assessed based solely on visible, above-ground features, as subsurface infrastructure remains inaccessible without specialized evaluation methods. Above-ground utility components observed include chillers, transformers, and gas meters, which fall under the purview of mechanical and electrical disciplines for detailed assessment. From a civil engineering standpoint, the utilities that can be evaluated- namely water and sanitary sewer systems- are typically located underground, making visual inspection insufficient for determining their condition. Accurate assessment of these systems would require more elaborate investigative techniques such as deploying video cameras through the sanitary sewer lines to identify structural or flow issues and conducting pressure testing on the water distribution system to evaluate integrity and conducting pressure testing on the water distribution system to evaluate integrity and performance.

If the owner has not experienced any operational issues with these systems, they may continue to function adequately. However, given that portions of the building are over 50 years old, it is likely that these utilities are original to the structure. Aging infrastructure can pose risks related to reliability, efficiency, and compliance with modern standards. Therefore, a thorough evaluation is recommended to determine the current condition and capacity of these systems.

Upgrades or replacements may be necessary to ensure long-term serviceability and alignment with contemporary building codes and utility performance expectations.

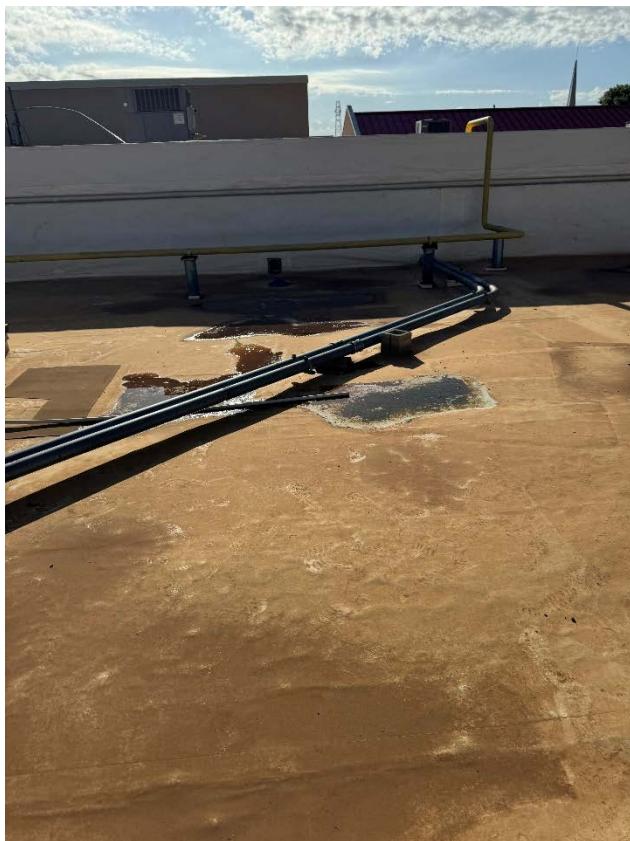
The roof, though relatively new, does not appear to have adequate slope which causes ponding and has deteriorated some areas and substrates. No failures in the roof membrane were noted but inadequate drainage could decrease the life expectancy of the system.

Figure 11 –Roof Ponding

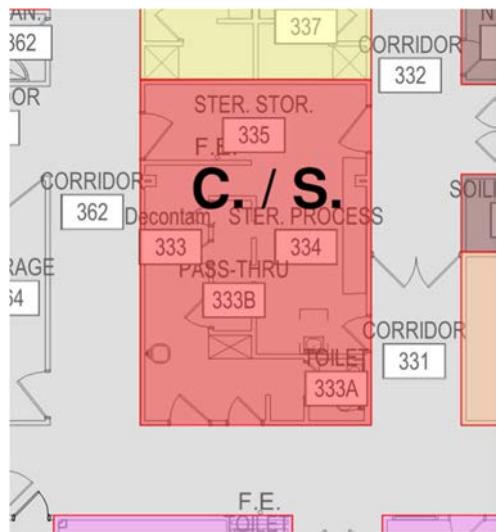
Figure 145 –Central Sterile Supply Suite

Missing required spaces include: a Breakdown storage room, Equipment storage, Cart storage, Office space, and a (dedicated) Housekeeping room within the Decontamination room. Staff facilities are provided however the single user toilet is only accessible from within the Decontamination room and does not appear to be sized for accessibility. For finishes, it appears that the primary entrance for the Decontamination room is located off of a corridor with carpet, thus raising questions about infection control.

Upon further review of the operational flow and processes we can recommend which spaces to connect to periphery access such as corridors that surround the suite. Within the suite, modifications can be made to ensure the delineation and separation of “dirty” and “clean” spaces.

Addressing missing required spaces may be easier to solve compared to other departments since specific square footages are not outlined for the various areas within the Central Sterile Supply Suite. Equipment storage and Cart storage may be effectively combined into a Multipurpose room if a safe operational flow is maintained. Additional spatial demarcations may be easily accomplished if equipment and processing can be reviewed for efficiency, and missing spaces can be added. Additionally, all finishes within the Department and immediate adjacent areas should be reviewed for maximum cleanability and durability to alleviate potential infection control issues for the Hospital.

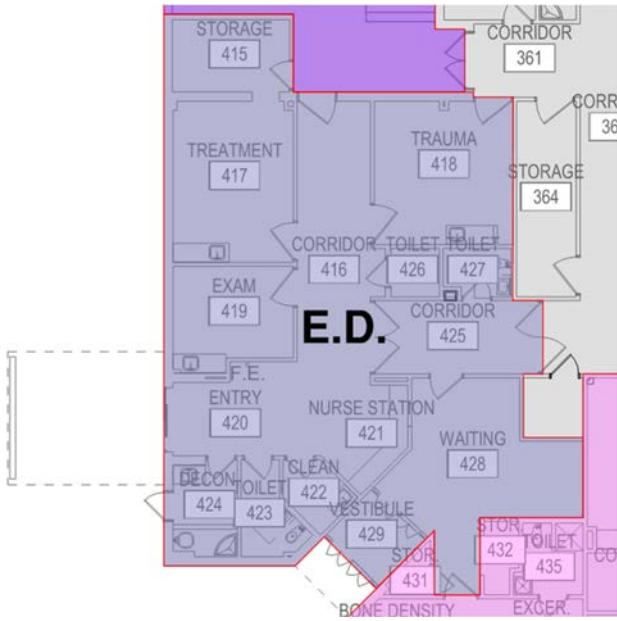
Figure 167 –Emergency Suite

There are numerous required spaces that are missing or don't meet minimum TDSHS standards. Required spaces that are missing are Wheelchair and Stretcher Storage, Soiled Workroom, Housekeeping, and Staff Toilets. While there is a toilet right outside of the suite, it fails to meet minimum accessibility standards and doesn't appear to be staff only dedicated. A required soiled workroom with a work counter, clinical sink and hand washing fixture is not present nor is there a Housekeeping Room within the suite.

Most of the required spaces that are present fail to meet the required minimum standards. A patient toilet is in an appropriate location but is too small to meet accessibility requirements. A separate ambulance and walk-in entrance to the Emergency department is present, but the walk-in entrance lacks proper signage. Regulations call for entrances to the Emergency Department to be "well-illuminated, identified by signs, and protected from inclement weather". The signage that is there is small and not illuminated. Also, the "Ambulance Entrance" sign on the north of the drive through is peeling and is losing legibility. There are no public toilet facilities for the exclusive use of the waiting room. Medical staff work area and charting area are all combined into the small control station. This area is inadequate for the required staff. There is no soiled workroom There is a small Clean Storage room that is extremely undersized. There are multiple issues with the required Decontamination Room. The current room does not meet the required 80 s.f. minimum. There is also a requirement for two handheld showerheads with temperature control. Additionally, there is required a drain that goes to a dedicated holding tank so that water from the shower does not enter the septic sewer system. The room that is designated "Trauma" does not meet minimum 250 s.f. requirements. It also lacks a scrub sink, and 6" integral coved base.

Renovations to the Emergency Department in its current location are not possible without expanding into another part of the hospital. Some required spaces are missing or vastly undersized. Based on where the hospital sits on the site, there does not seem to be a feasible way to expand the current footprint of the building to give the department the additional area needed. The one possible option is to expand to the north into the outpatient area. This

recommendation comes without deeper discussion and understanding of how the outpatient department operates and the needs of that space. In its current location, the outpatient suite appears to be ideally situated next to surgery and encroachment into that space could prove problematic.

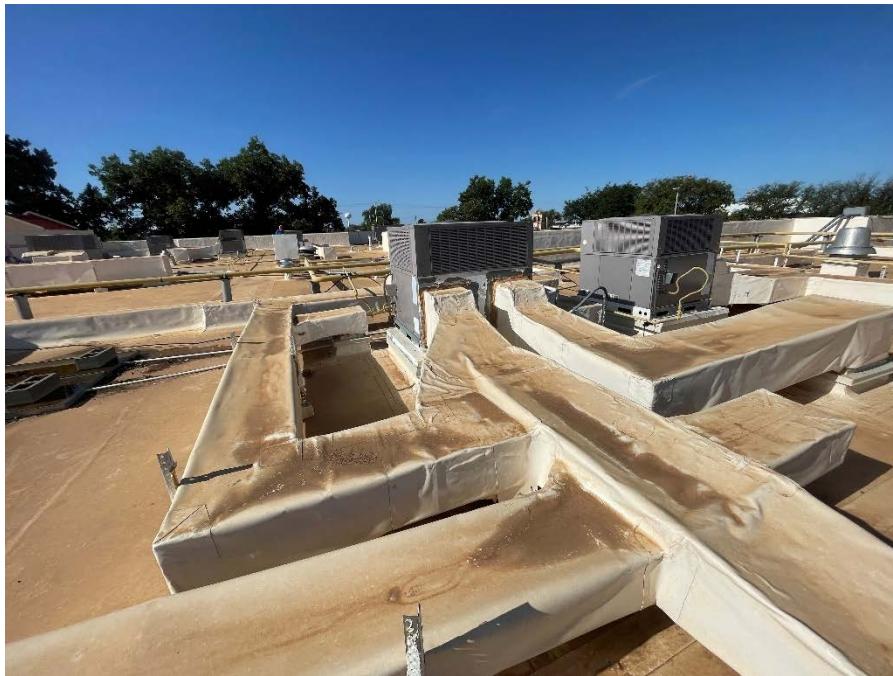
**Existing HVAC Systems:** The southern portion of the building is served by gas-fired package rooftop units (RTU). These units vary in their condition, primarily due to the age of the units. There is one RTU in the southwest corner of the roof that is mounted on an adapter curb with the supply and return air ductwork discharging vertically into the ceiling space below. The rest of the RTU's, on this portion of the building, have horizontal supply and return air outlets with the existing ductwork routed on the roof. The existing exterior ductwork is in poor condition. The example of deformed and damaged ductwork, shown below, is systemic for all exterior mounted ductwork.

Figure 19 - Example of RTU's with Exterior Routed Ductwork

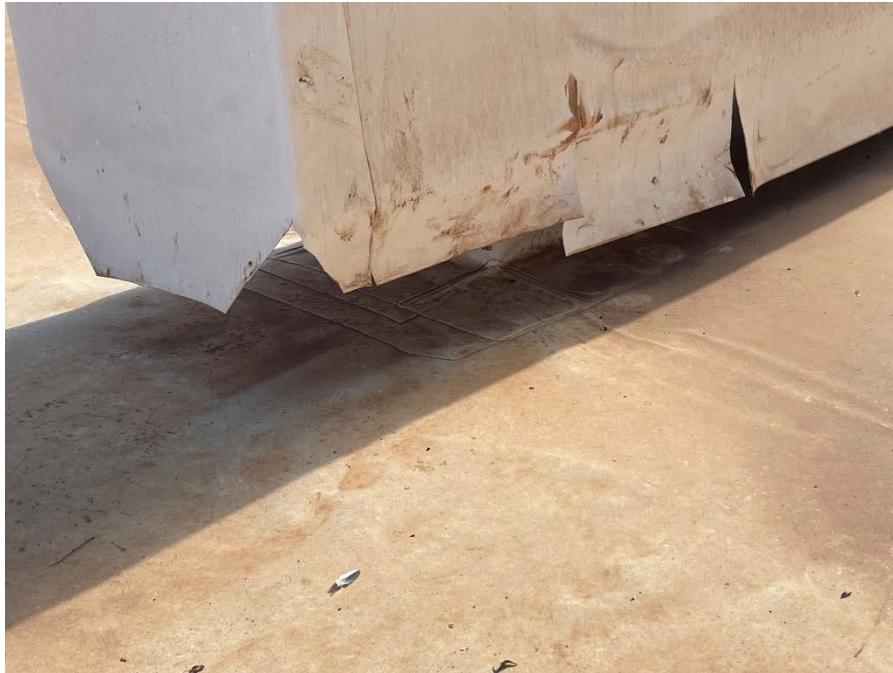
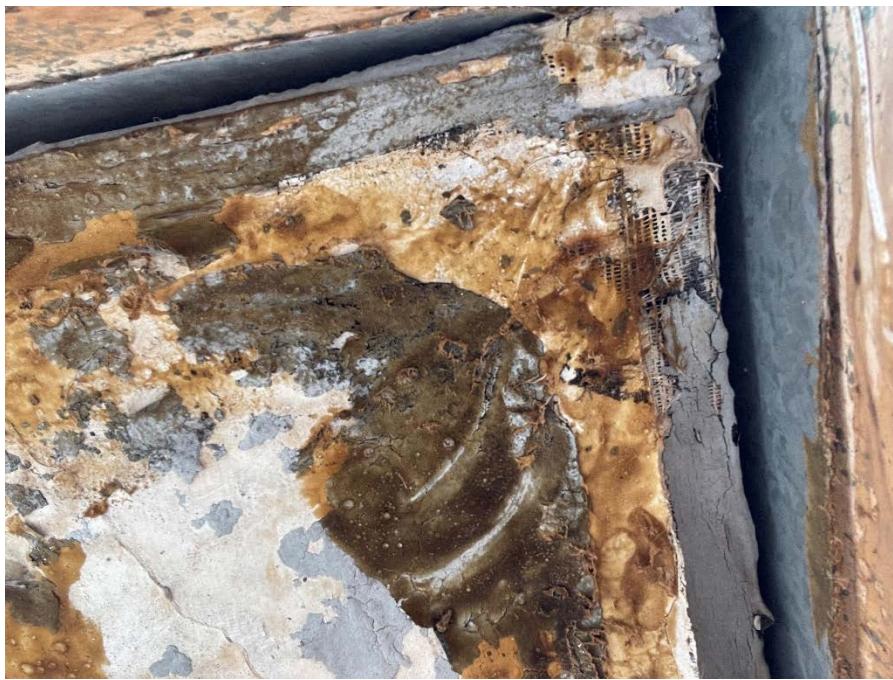
Figure 20 - Example of Exterior Ductwork Degradation, visible portion

Figure 21 - Example of Exterior Ductwork Degradation, bottom view of ductwork

The existing exterior jacketed ductwork is damaged all over and in need of replacement. There are numerous portions of the exterior ductwork that are damaged with the upper part of the ductwork having been dented down, thus restricting the designed air flow by reducing the free area of the ductwork.

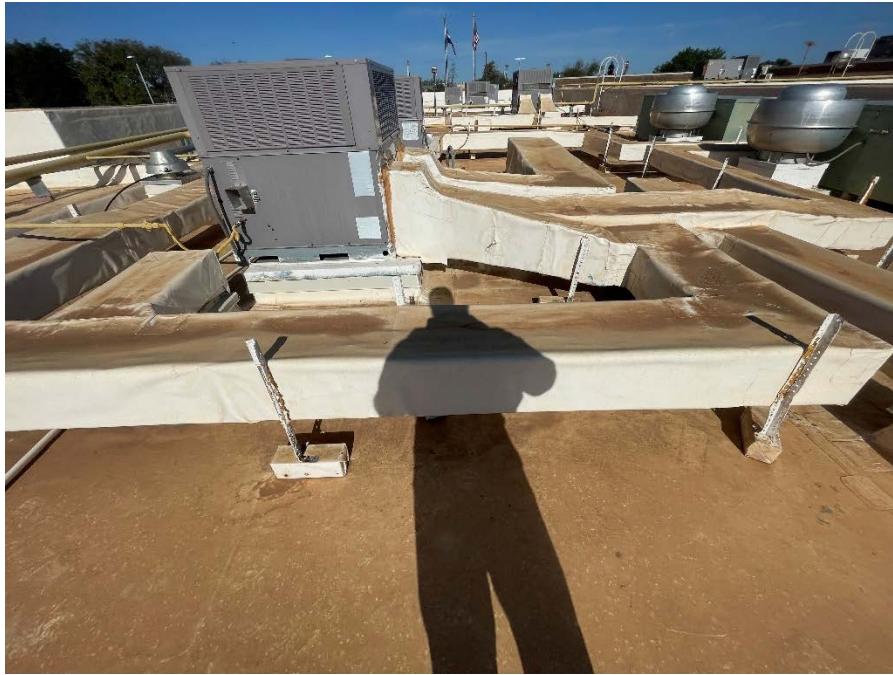
*Figure 22 - Example of No Outside Air Intakes on RTU's*

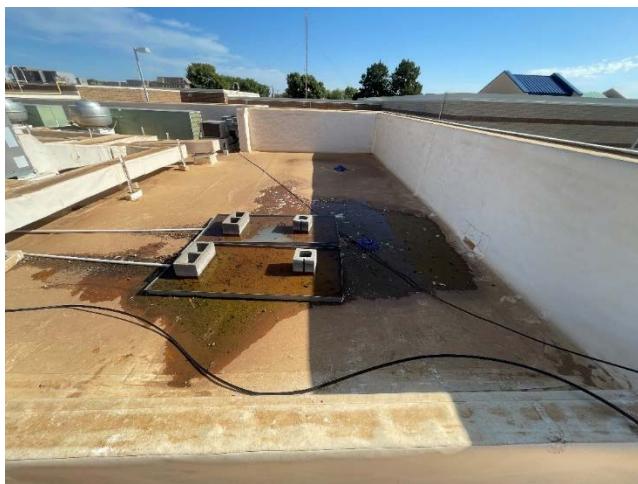
There are numerous evaporation pans for the condensate drainage for the RTU's are in place around the roof. Standing water on the roof can cause troublesome issues; a condensate drainage system disposing the condensate through the existing sanitary sewer system or terminating the condensate at primary roof drains are better at maintaining a drier roof.

*Figure 23 - Existing Condensate Evaporation Pans*

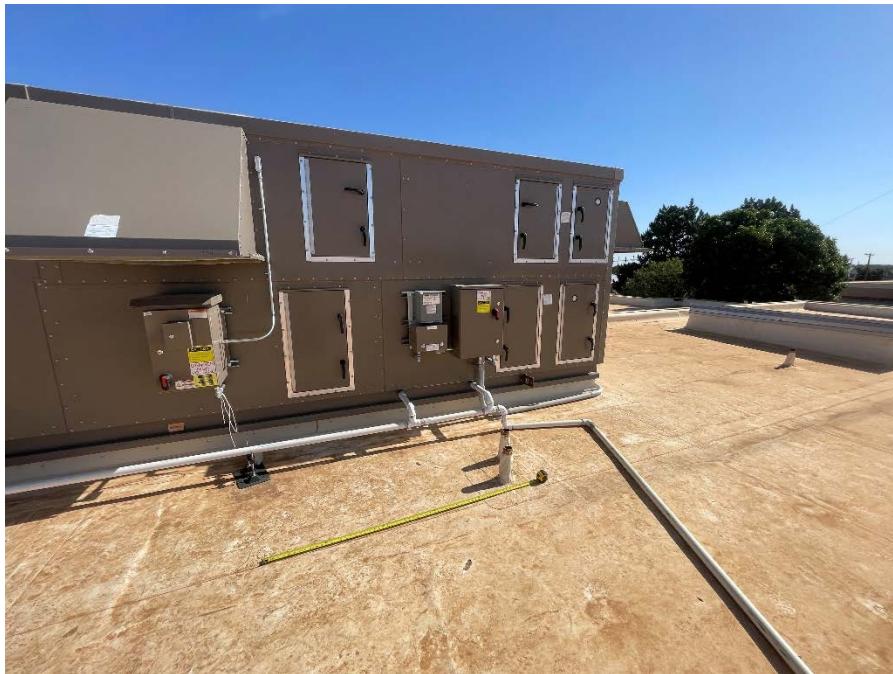
The RTU's serving the hospital areas do have outside air intakes on the units. The existing RTU's configurations appear to meet the current Texas Department of State Health Services (TDSHS) requirements. The main issue observed concerning the hospital RTU's is the placement of several plumbing vents. Per TDSHS code, no exhaust or plumbing vents shall be closer than 25'-0" from any outside air intake for a hospital (Texas Administrative Code Chapter 133.161.3.D.i.III). The code allows for plumbing vents to be no closer than 10'-0" away from the outside air intakes but must be a minimum of 5'-0" above the level of the outside air intake.

Figure 24 - Plumbing Vents Closer than 25'-0 to RTU

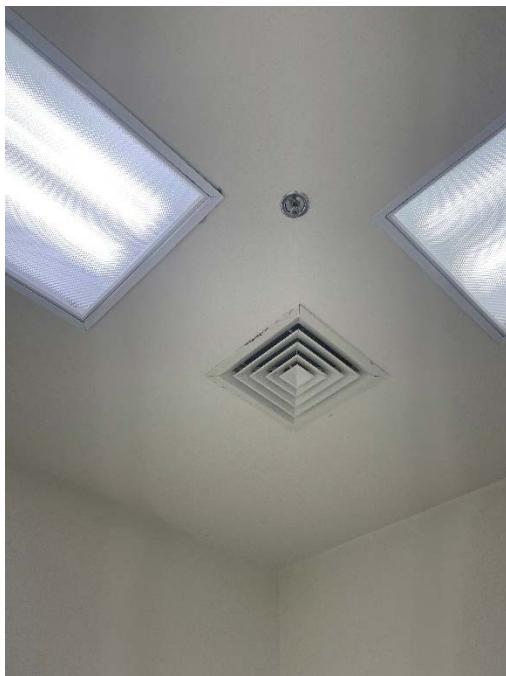
The air distribution systems throughout the hospital appear to meet the current TDSHS and ASHRAE standards for non-critical health care areas; however, the operating rooms do not meet the current design standards for Group E non-aspirating type air distribution. Operating rooms should have non-aspirating laminar flow covering the operating table and overlap by 12 inches. Given the sterile nature and the required cleaning practices of operating rooms, supply, return, and exhaust air grilles should be of stainless-steel construction. The existing grilles appear to be painted steel grilles due to the rust beginning to form at the edges of the grilles. A minimum air change rate of 20 to 25 air changes per hour along with a minimum of 4 outside air changes per hour should be confirmed for each operating room. The ability to maintain 30% to 60% relative humidity in the operating rooms should be confirmed to meet current TDSHS standards.

*Figure 26 - Ceiling Supply in Operating Room, rust showing on the edges*

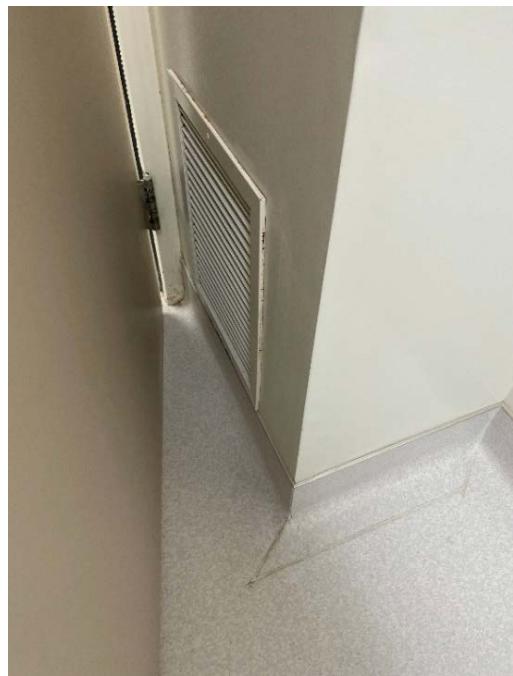
*Figure 39 - Low Return in Operating Room, rust showing on edges*

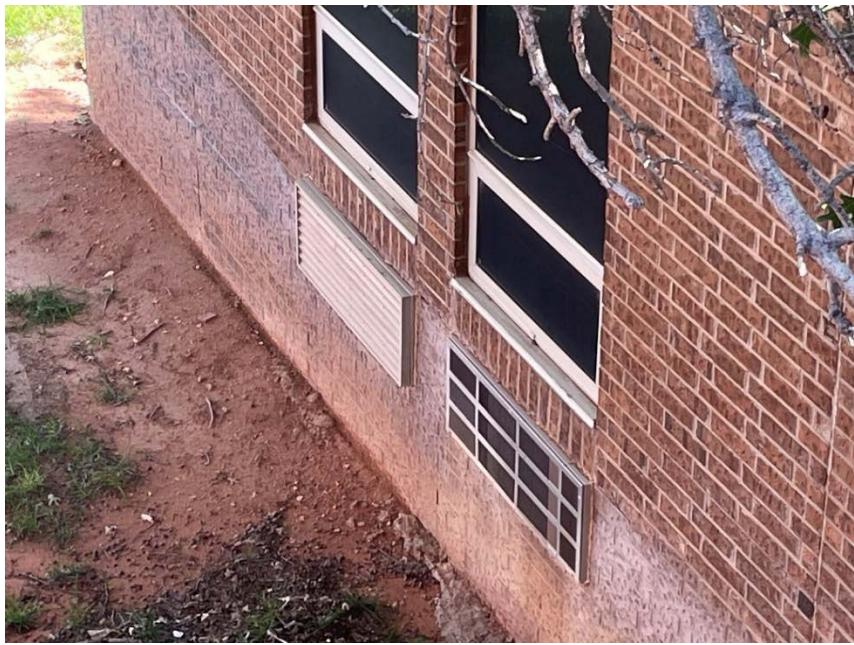
The existing patient rooms are conditioned by package terminal air-conditioning units (PTAC). TDSHS requires minimum 2 outside air changes per hour with a minimum 6 air changes per hour; while some PTAC's are capable of these requirements, it is not apparent that the existing units are capable of the outside air requirements. The outside air needs to be supplied to the rooms through an air handling unit with two filter banks, a pre-filter of MERV 7 and a final filter of MERV 14. There is no apparent method of TDSHS required outside air supply to the patient wings.

*Figure 27 - Existing PTAC Units of Patient Rooms*

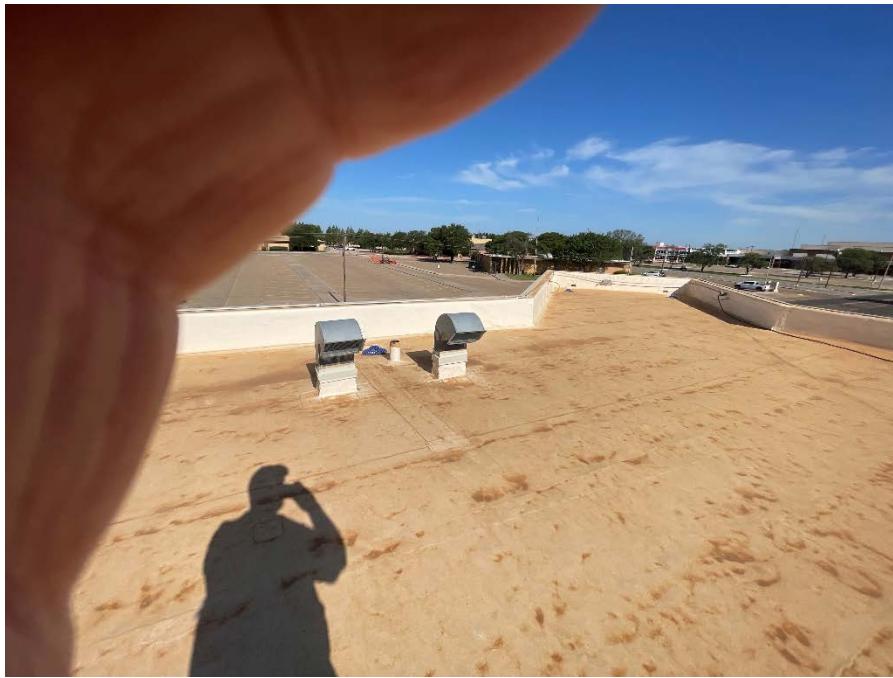
The two existing goosenecks appear to be supplying exhaust air to areas below. Per TDSHS code, no “positive” pressured exhaust ductwork is allowed inside the hospital, in basic terms all exhaust fans shall be roof mounted in order to only have “negative” pressure exhaust duct inside the hospital. Further investigation would need to occur to discern the systems utilizing the goosenecks.

*Figure 28 - Existing Goosenecks on Hospital Roof*

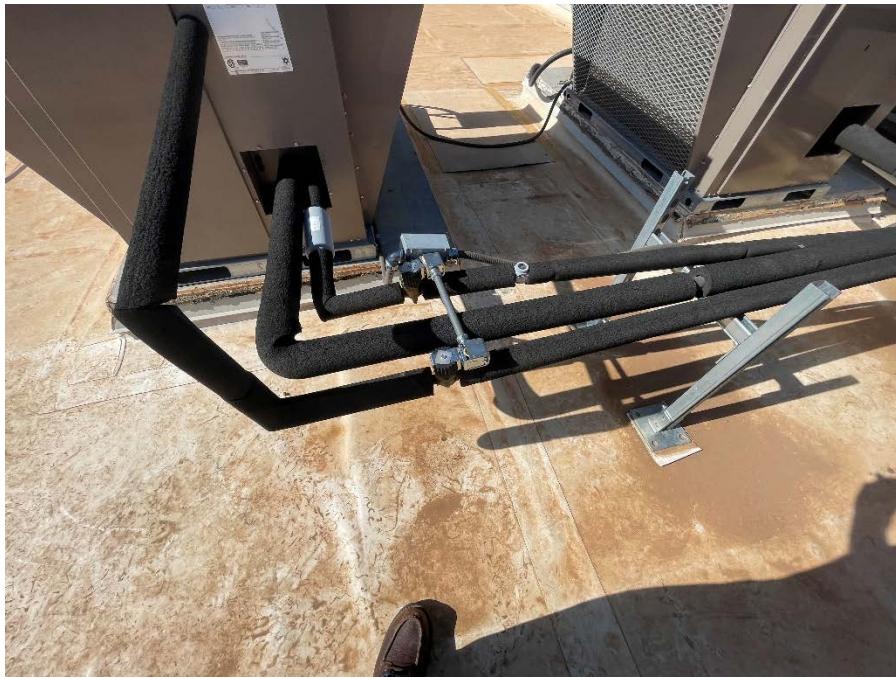
The refrigerant piping from the air-cooled condensing units to the RTU's for the hospital area were insulated for the most part; however, they are showing signs of wear due to exposure and there were gaps in the insulation. Proper refrigerant pipe insulation jackets should be installed to preserve the life of the refrigerant pipe and provide continued efficiencies.

*Figure 42 - Existing Refrigerant Roof Piping Insulation*

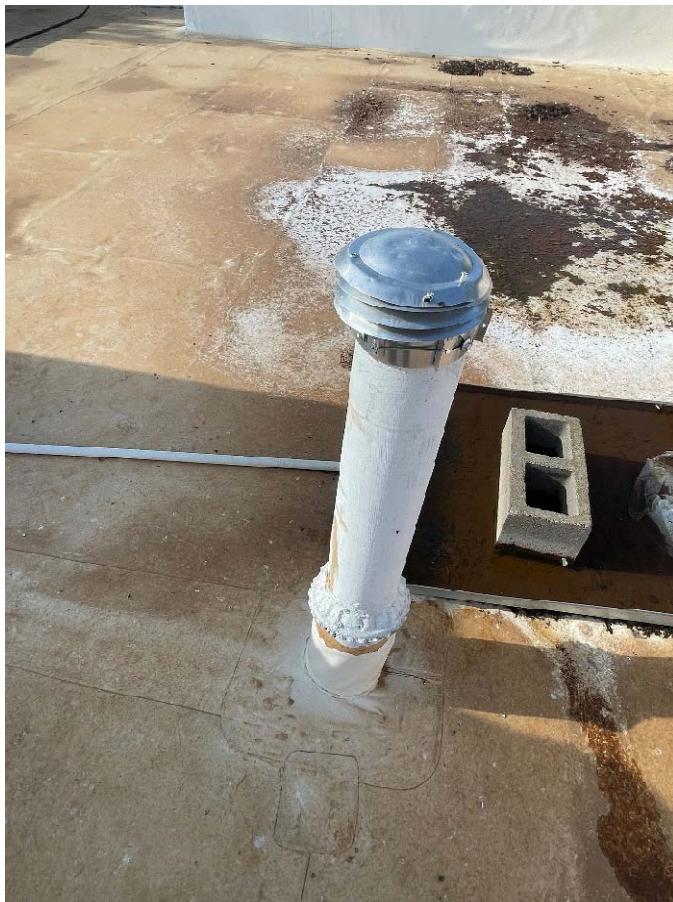
Figure 29 - Hail Damaged Flue Vent Termination

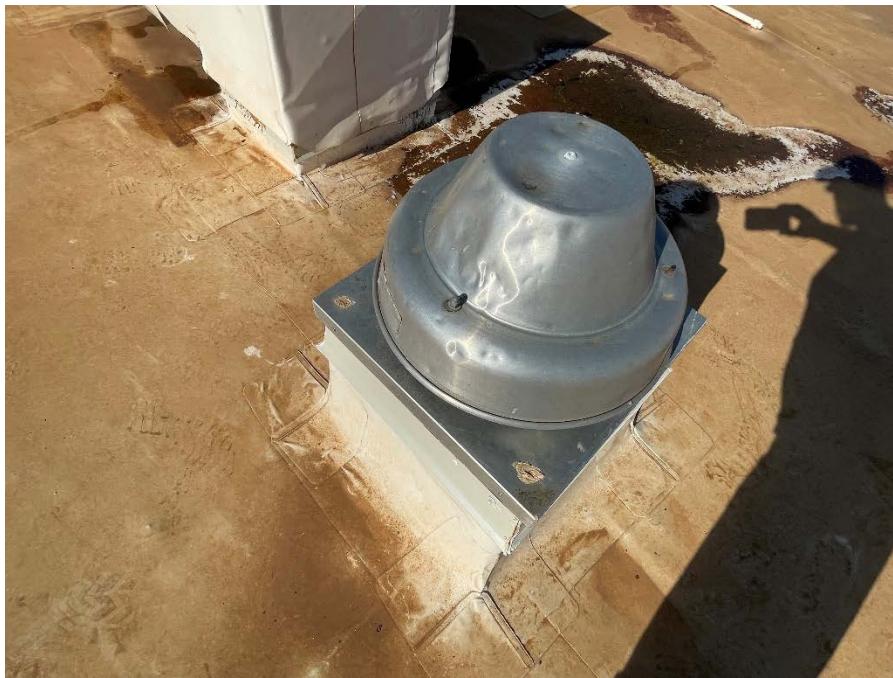
Figure 30 - Hail Damaged Exhaust Fan

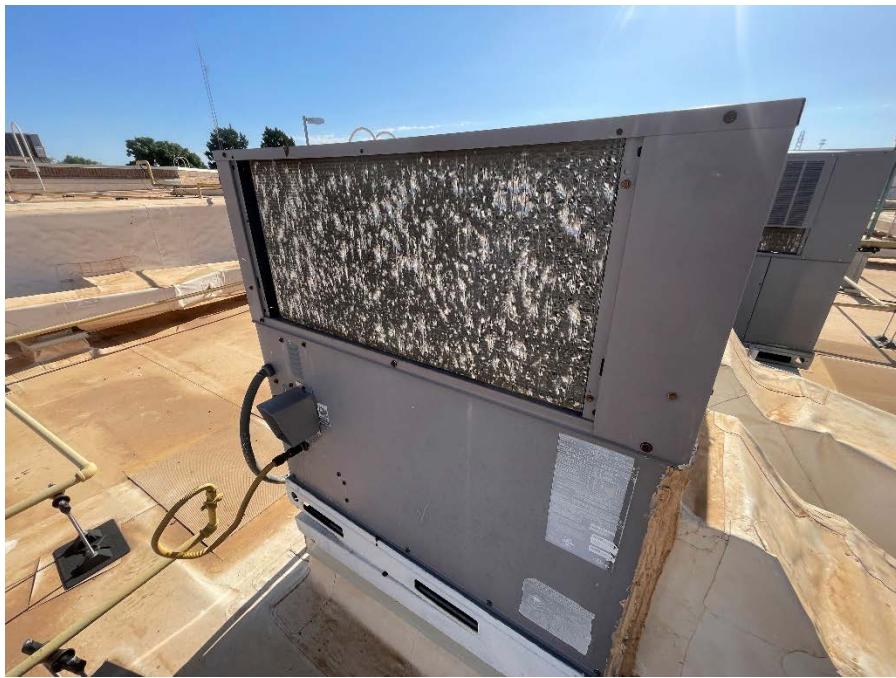
Figure 45 - Hail Damaged RTU Condenser Coil Fins

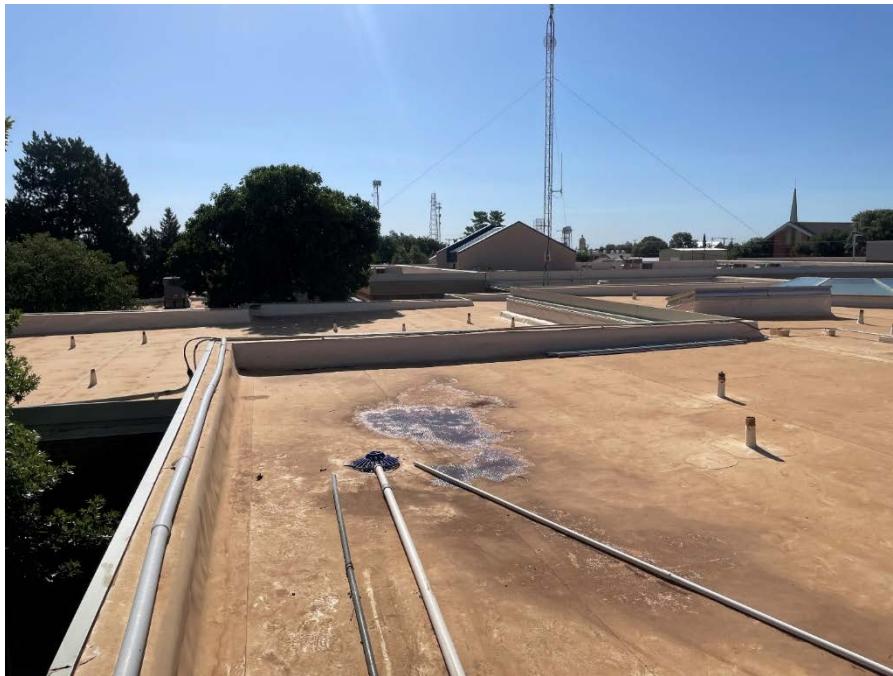
various pictures of the ponding water, debris, and dirty darker discoloration all over the existing roof areas.

*Figure 33 - Example of Roof Sag*

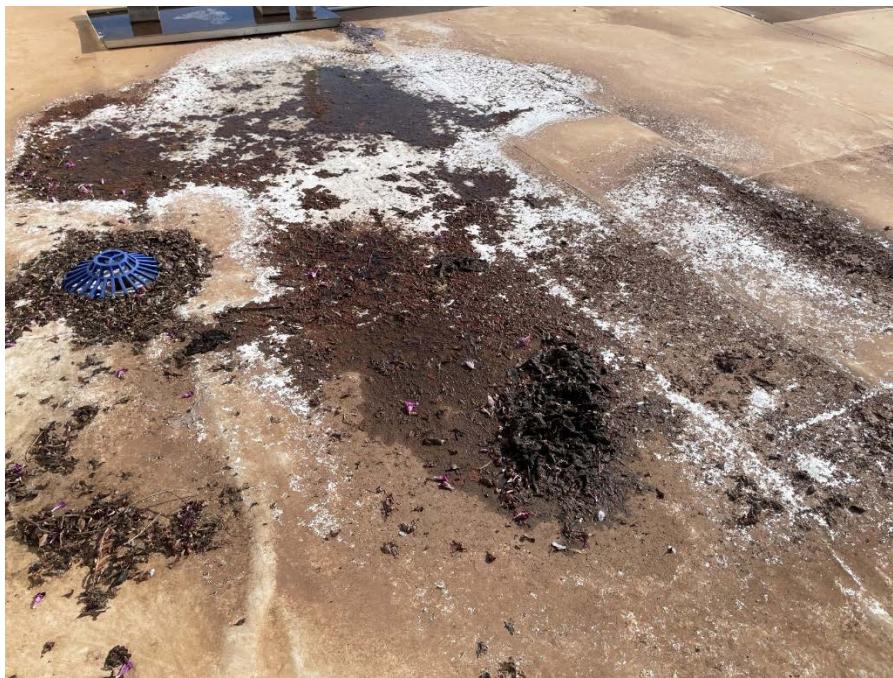
*Figure 34 - Example of Roof Sag, Debris, and Severe Ponding*

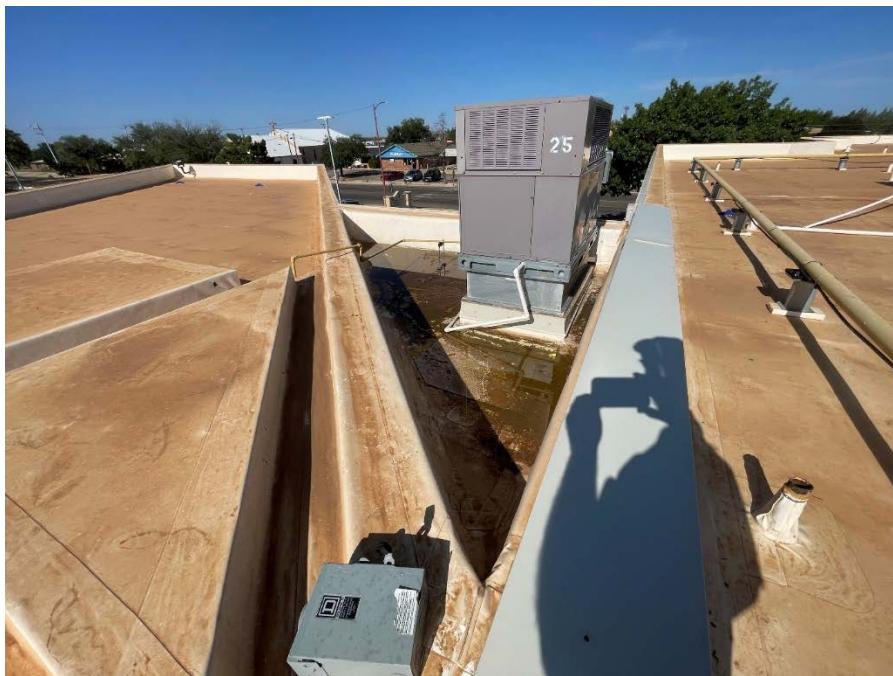
was noted that there were multiple roof drains that did not have adequate slope provided to the roof drain fixture thus adding to the ponding issue throughout the roof areas. One notable area on the roof has severe ponding issues as shown in the following picture.

Figure 35 - Roof Area with Poor Drainage

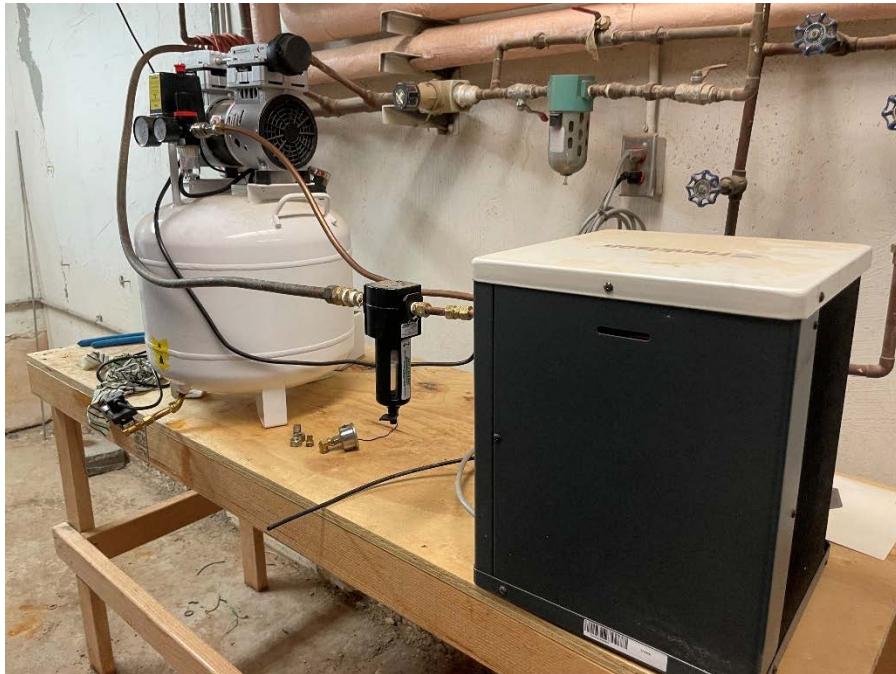
The existing medical air compressor system appears to be in fair condition with the required filtration and air dryer accessories. It will need to be verified if the size meets the required TDSHS standards for medical air based on the size of the hospital's medical air requirements; however, this is doubtful. The air intake appears to be provided from within the space, which is not allowed by TDSHS requirements and should be addressed.

Figure 38 - Existing Medical Compressed Air System

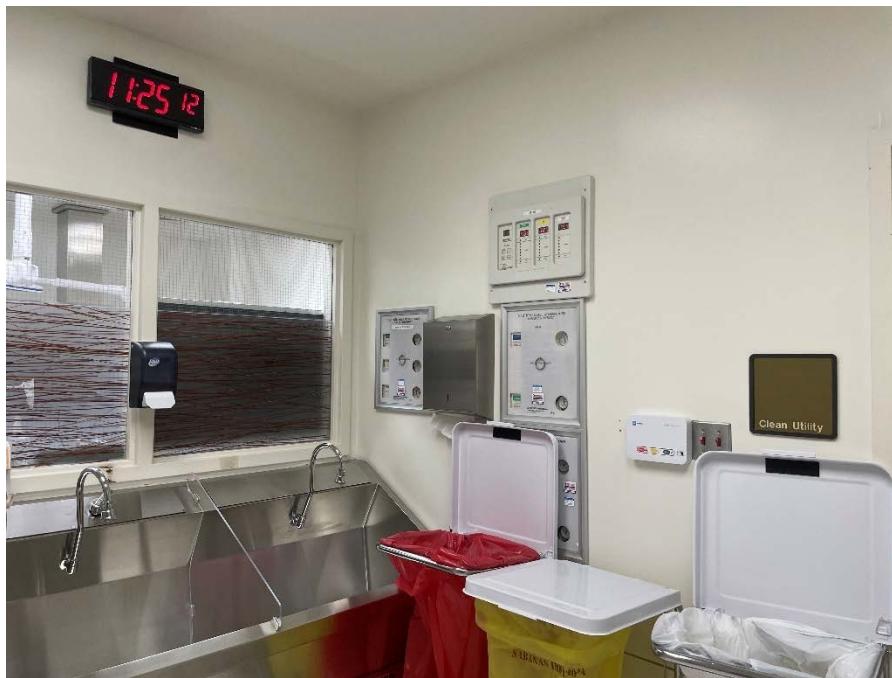
The medical gas system throughout the hospital appear to meet the current TDSHS codes for zone valves and zone monitoring requirements. Each OR had its own zone valves and alarms and the OR's appeared to meet the minimum medical gas outlet requirements. The static pressures observed for the medical gases in the OR area were stable at the minimum required levels; however, there were no procedures occurring at the time of the site visit. The medical gas system is Chemetron. The OR's, ER rooms, and patient rooms appear to meet current minimum TDSHS standards for the number and type of medical gas outlets required. There are locations where proper or required access to zone valves and alarm panels are in question and should be addressed to allow for easier access.

Figure 41 - Questionable Access to Medical Zone Valve Assemblies

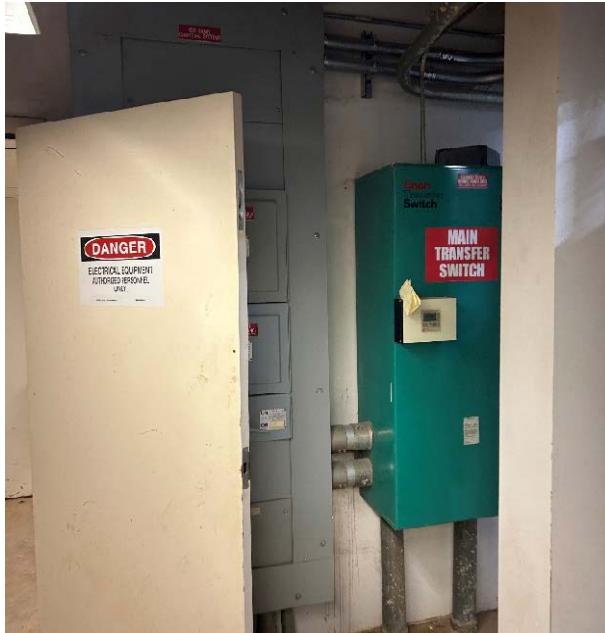
Figure 45 – Main Transfer Switch Blocked by Column

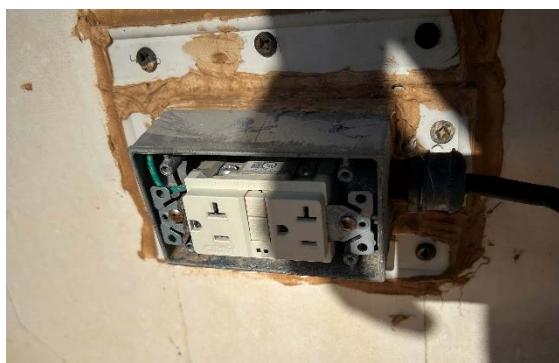
Figure 48 – Electrical Box Missing Cover
