## **FACILITY ASSESSMENT REPORT**

**YOAKUM COUNTY HOSPITAL**

**Denver City, Texas**

Parkhill Project # 45841.25

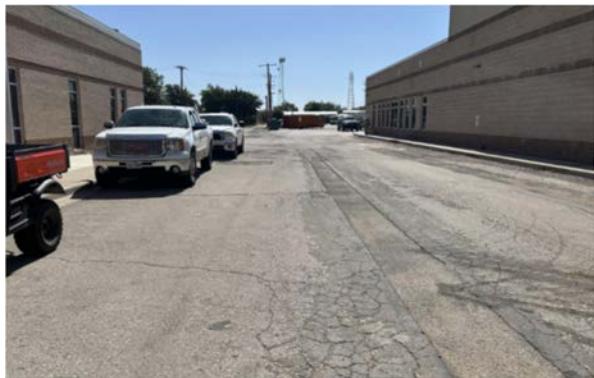
The pavements are in poor condition with cracks sprawling throughout a majority of the paved areas that are larger than 1-inch in width. However, since there is no vertical elevation difference, a remediation option might be to strip the surface pavement and rework the base, including proof rolling prior to overlaying the HMAC surface with a depth to match what was existing prior to removal. Additionally, several areas within the pavements exhibit poor drainage, which will require improvement.

Figure 3 – East Service Drive

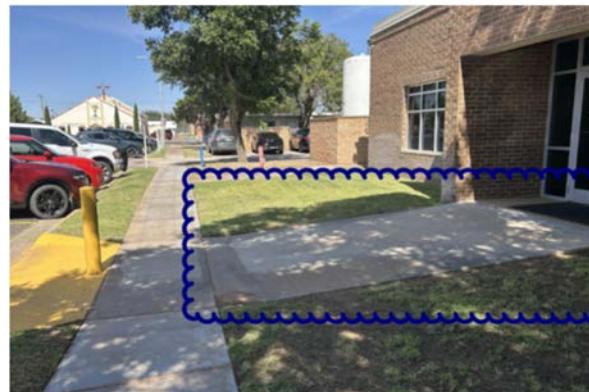
Multiple areas across the site appear to be non-compliant with current ADA standards. Several ramps were observed to have incorrect configurations, including slopes exceeding the maximum allowable 1:12 ratio and lacking proper landings or edge protection. Parking areas also exhibited slope conditions that are likely to exceed the 2% maximum in any direction, as clarified in the 2025 ADA updates. Additionally, handrails on existing ramps do not meet the latest ADA specifications, such as proper height (34–38 inches), continuous gripping surfaces, and required extensions beyond ramp segments. To ensure full compliance with today's ADA standards and avoid potential enforcement actions, all identified deficiencies will need to be addressed through corrective design and construction measures.

Figure 8 – South Entrance to Rehab Too Steep

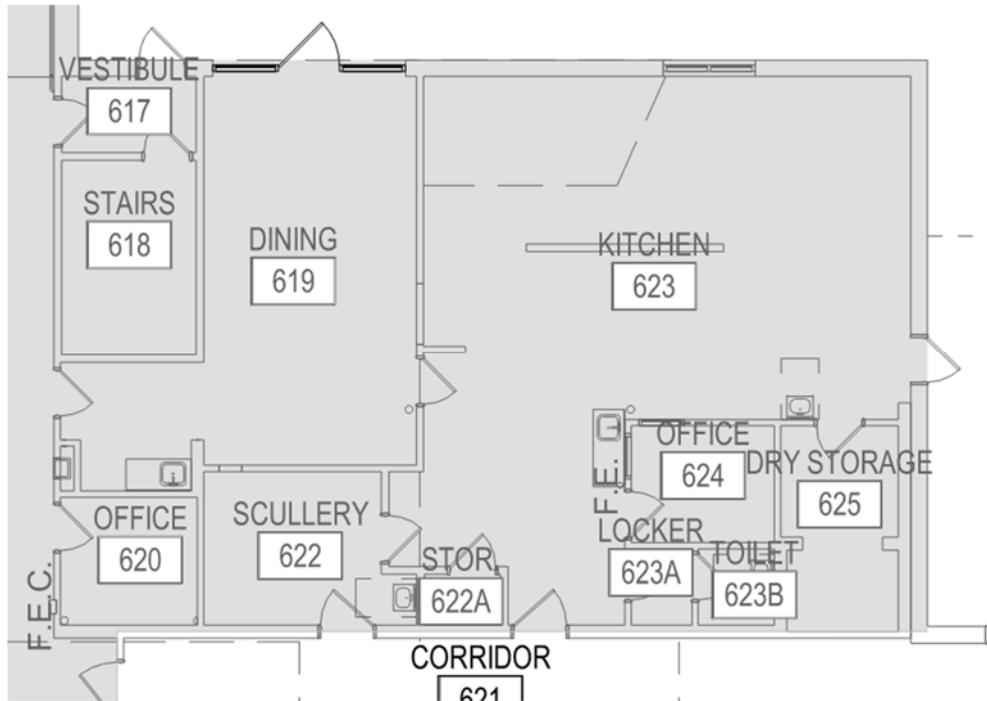
Figure 156 –Dietary Suite

A few required spaces were not noted or did not meet current requirements. There is not a required housekeeping room within the suite. Staff toilet and locker space are required but are undersized and do not meet accessibility requirements.

While there are some non-compliant pieces, no major issues are noted. A larger, updated kitchen would be desired but not necessary.

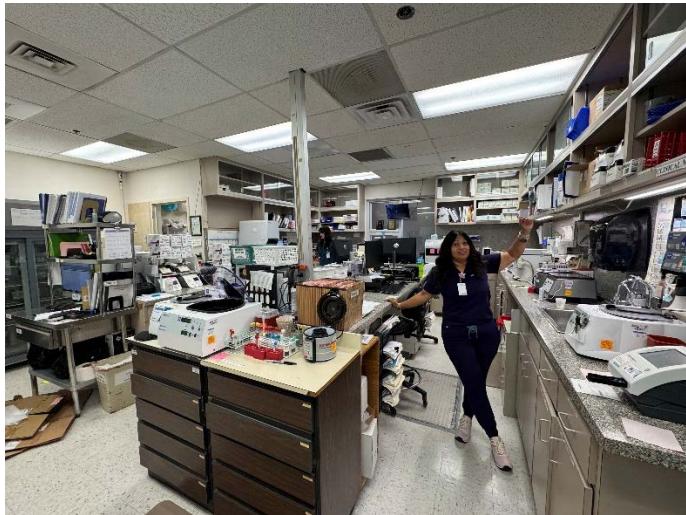
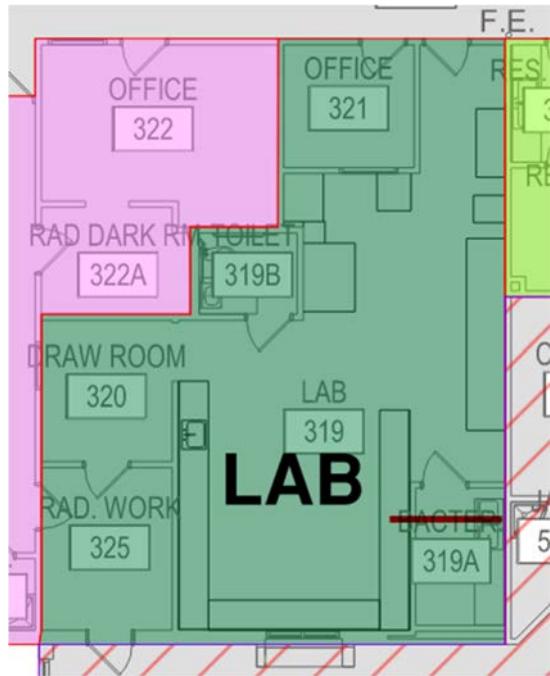
Figure 20 –Laboratory Suite

The hospital's lab is undersized, creating an overcrowded space lacking adequate storage and workspace. This is very common in hospitals of this age where the labs were not designed with the current modern equipment needs in mind. Several required areas are missing or don't meet minimum requirements.

In general, the lab is too small for the equipment, staff, and storage needs. The laboratory workroom is present but does not have space appropriately designed for the equipment. The walls are lined with storage cabinets and shelving, but our observation was that it is inadequate for the lab's needs. Hand washing facilities appeared to be adequate and meet the requirements, but it was noted that the staff constantly battles plumbing leaks and backed up drains. There is an office that, while small, appears to be adequate. Staff facilities, including a lounge, locker and toilet facility are required. These can be located outside of the suite or shared with another department, but we did not observe one present nearby. There is a small toilet in the suite, but it does not meet accessibility standards. A small closet in the suite is being used as a makeshift lounge. There is a blood draw station, but the location is awkward as it's in a traffic area. A housekeeping room is required but not present.

There is nowhere to expand the lab as it is landlocked on all sides with other departments. The lab could be relocated to another area on the property or even an off-site location, but this is not ideal. The lab is currently located in the perfect spot in the hospital near the emergency, surgery, OB, and nursing departments. Relocating to another location would adversely affect the timeliness of lab response. The space could be renovated in its current location to improve flow, but the current space constraints would limit how much improvement could be made and would not be able to meet all requirements.

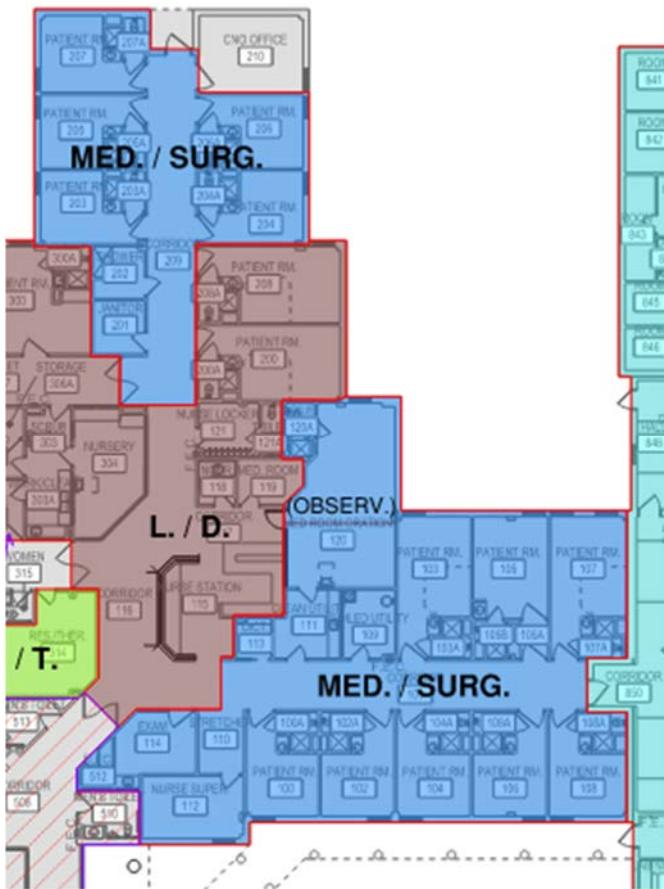
*Figure 24—Nursing Unit Suite*

The nursing unit is the central patient area of the hospital. The current suite functions but is deficient in numerous areas. For the most part deficiencies are a result of the building's age and the era in which it was built. There is also a lack of delineation between the Nursing Unit and the OB suite.

A major renovation of the space could bring the space up to standard but there likely is not enough area within the current footprint to accommodate any renovation. Expanding into another area of the hospital would likely be required.

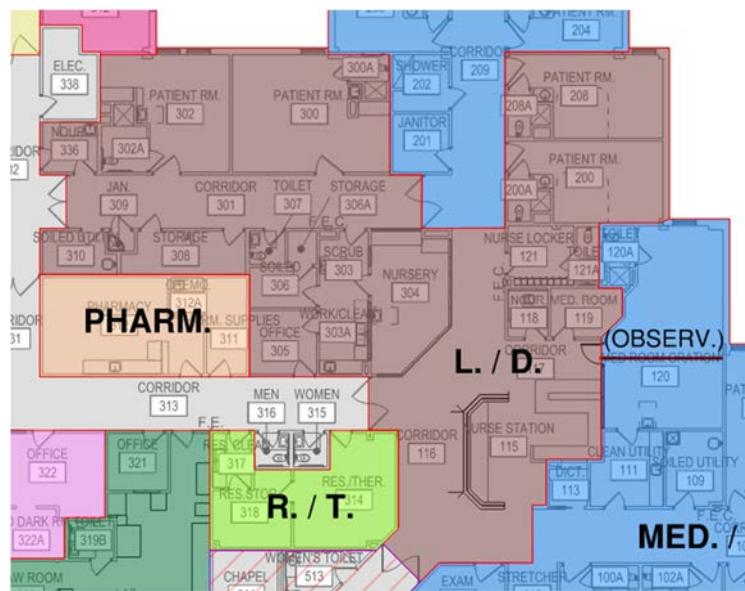
Figure 25 –Obstetrical Suite

It is not possible to develop and arrange the required spaces of an Obstetrical Suite to meet minimum standards within the existing square footage and suite footprint. There would inevitably be consequential disruption to adjacent departments.

The primary challenge is bulking Obstetrical Suite areas together to preclude other department traffic. The current operational flow and overlap between Medical / Surgical and the Obstetrical Suite is problematic. Re-defining these departments would entail reassigning some spaces such as Medical / Surgical areas and possibly Pharmacy. Centralizing viewing is also recommended to provide visual control for the suite access doors.

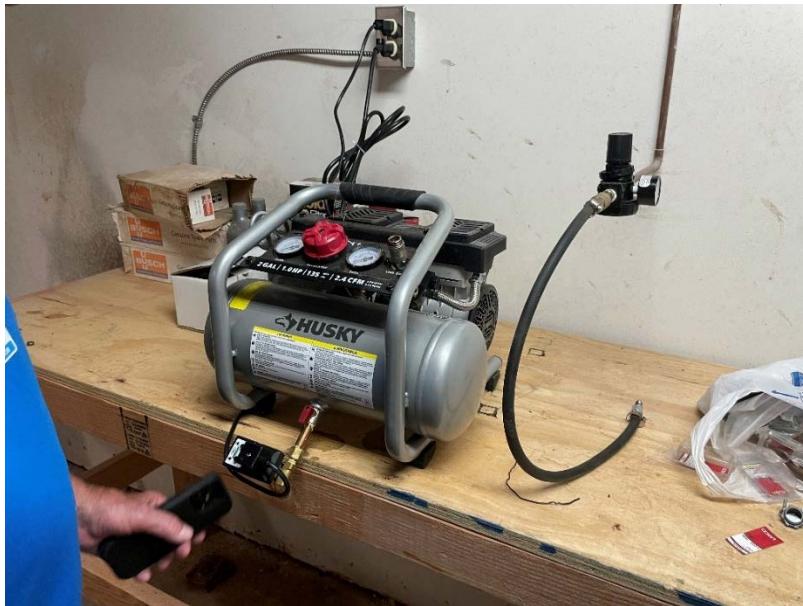
There is a small air compressor unit located in the basement that provides control-air to outdated thermostats that control heating only pieces of equipment. At the time of the assessment, the air compressor was not operational due to it not being needed based on seasonal temperatures. It was relayed that the system is activated once cooler weather dictates.

Figure 47 - Existing Heating System Control Air Compressor

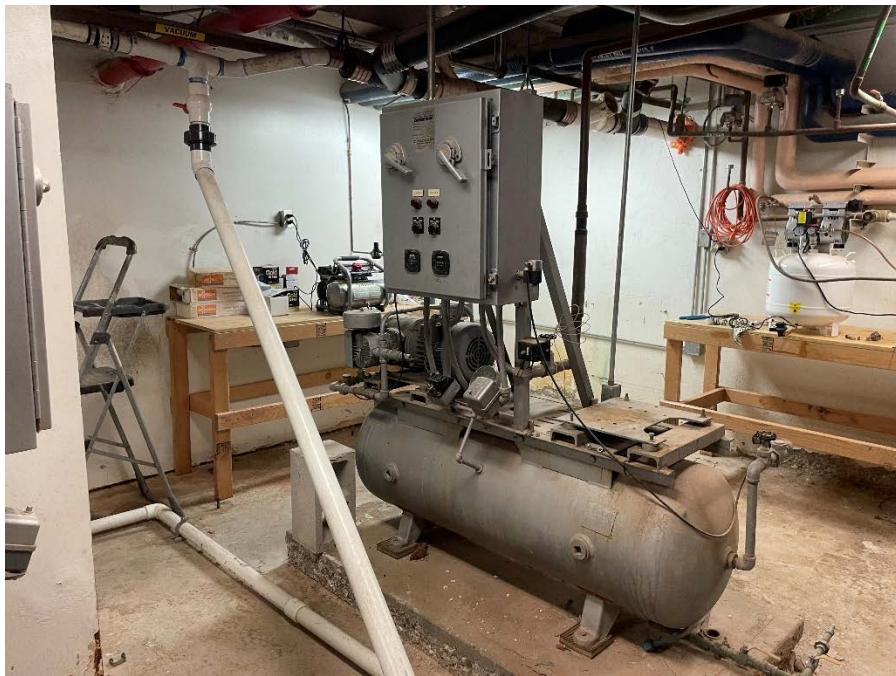
The medical vacuum pump system is operational having recently received a new vacuum pump. Currently the system is operating as a simplex unit; however, it was originally installed and operated as a duplex system. Should the vacuum pump become non-operational, the hospital would not have medical vacuum service to the hospital until a new vacuum pump could be installed. Per NFPA 99 and TDSHS, medical vacuum system shall be a minimum duplex system so in the event of a vacuum pump failure, the other vacuum pump can carry the required load, currently this is not the case. Proper venting of the medical vacuum pump system needs to be verified to meet current TDSHS and NFPA 99 standards.

Figure 37 - Existing Medical Vacuum System

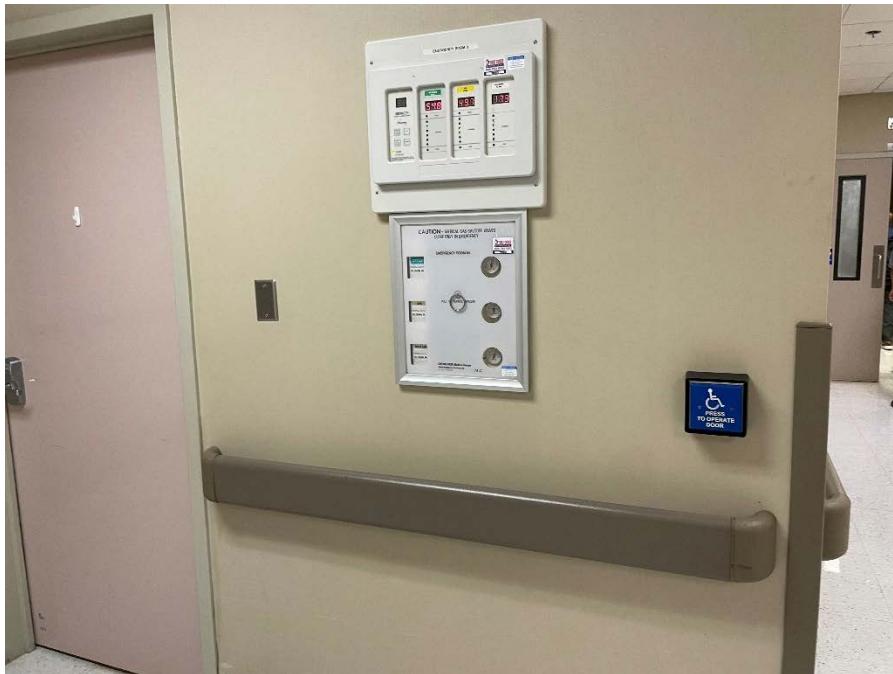
The medical gas system throughout the hospital appear to meet the current TDSHS codes for zone valves and zone monitoring requirements. Each OR had its own zone valves and alarms and the OR's appeared to meet the minimum medical gas outlet requirements. The static pressures observed for the medical gases in the OR area were stable at the minimum required levels; however, there were no procedures occurring at the time of the site visit. The medical gas system is Chemetron. The OR's, ER rooms, and patient rooms appear to meet current minimum TDSHS standards for the number and type of medical gas outlets required. There are locations where proper or required access to zone valves and alarm panels are in question and should be addressed to allow for easier access.

Figure 39 - Example of Medical Gas Zone Valve and Alarm Panels

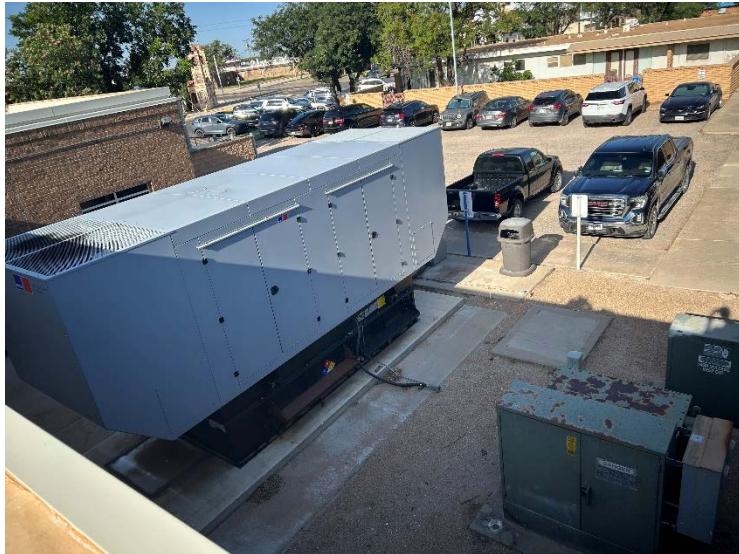
**Generator:** A 120/208volt, three phase diesel generator is located adjacent to utility transformer. The generator currently provides emergency backup power to several loads in the hospital but does not backup the entire hospital. The generator appears to be in good condition. The generator consists of an integral 1200-amp main circuit breaker and a 1000-gallon base tank. There is an emergency shut-off push button mounted on the generator. Recommendations include to relocate this switch to the nearest adjacent wall for safety reasons.

Figure 63 – Generator and Utility Transformer

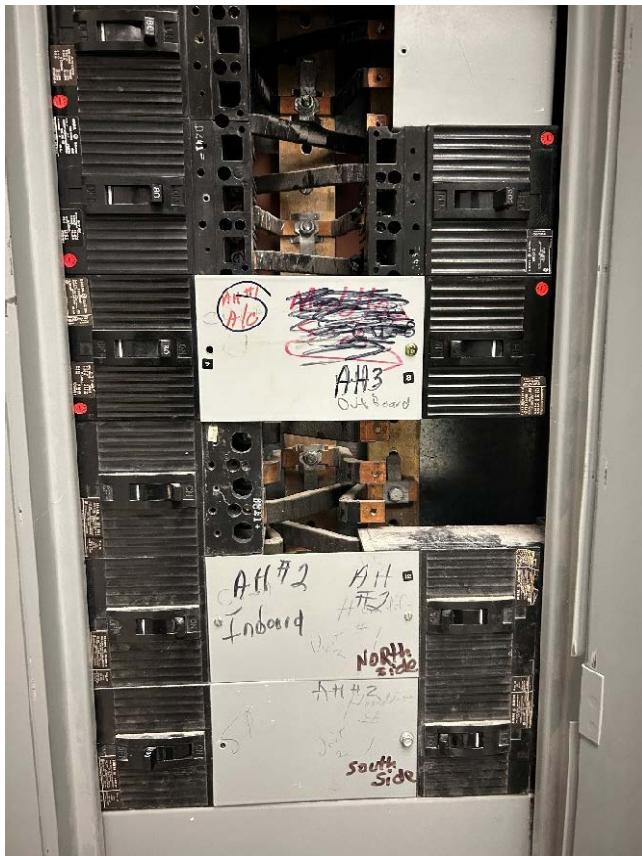
Figure 46 – Panel PB

The electrical rooms on the first floor have panels that appear to be in good condition except for panel PB. Panel PB has exposed components that need to be provided with proper cover plates. Branch panels in these electrical rooms appear to be interconnected with a shared grounding conductor share, per NFPA 70. Most of the panels have conduits that enter/exit the top side of the panel and are then routed to an exposed portion of the acoustic ceiling. The gaps appeared to have firestop pillows stuffed within without any way to secure them. Some of the pillows had fallen on top of the electrical panels. Both 1<sup>st</sup> floor electrical rooms observed had critical equipment and normal branch panels that were nearly full, with limited spare circuit breakers. Observations included equipment that appeared to be connected to the wrong emergency system (i.e. some of the circuits on the critical panels, when they should be on the equipment branch panels).

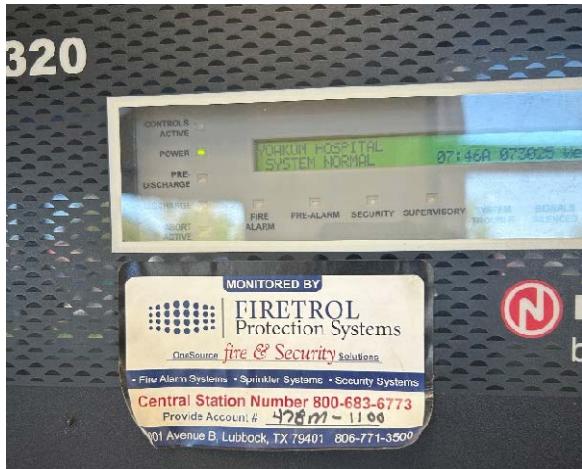
Figure 47 – Fire Alarm Panel

**Fire Alarm:** There is currently a fire alarm system located in the hospital. A Notifier NFS-320 is located at the south main entrance area. No issues were reported with the fire alarm system.

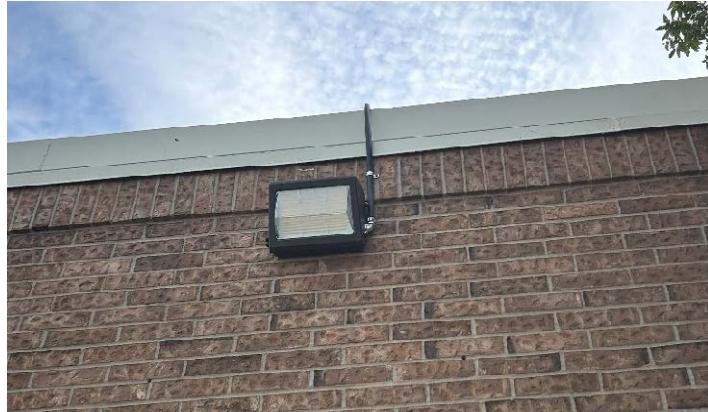
Figure 68 – Exterior Lighting

**Lighting:** The majority of the hospital appeared to have interior light fixtures that were in good condition. Exterior lighting appeared to be in good condition and seemed to be LED. No remediation is necessary currently.

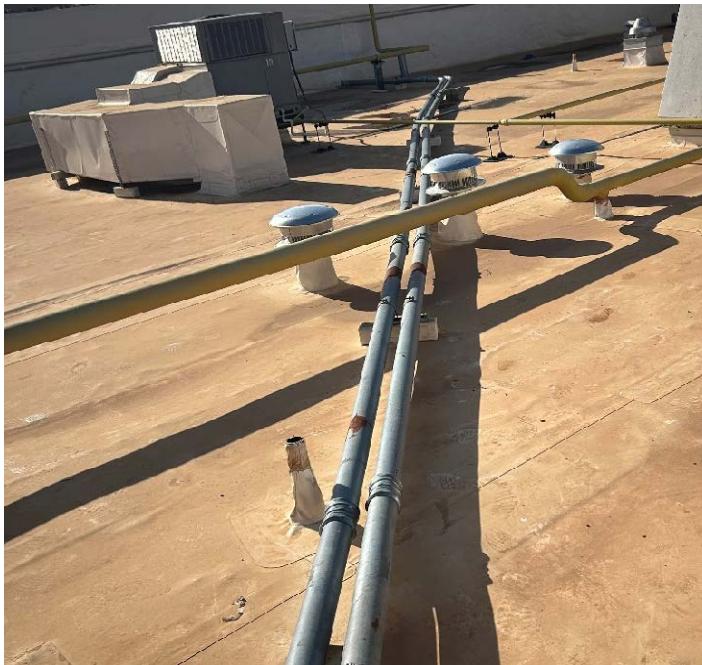
Figure 69 – Roof Conduit

**Roof:** There are electrical feeders routed above the roof connecting various electrical rooms/panels. Portions of the feeder conduits appeared to have rust and corrosion. Recommendations include replacing these conduits prior to exposed wiring being an issue. Observations also include a receptacle located on the roof that did not have a cover plate. Recommendations include providing cover plates and weatherproof while-in-use covers on all
